**SITUATION REPORT
INCIDENT COMMAND POST GOLD KING
GOLD KING MINE RELEASE INCIDENT
U.S. ENVIRONMENTAL PROTECTION AGENCY**

Subject: EXECSUM / SITREP #45
Gold King Mine Release Incident
San Juan County, Colorado
Latitude: 37.8945 Longitude: -107.6384

From: Situation Unit, Incident Command Post Gold King

Date: 13 October 2015

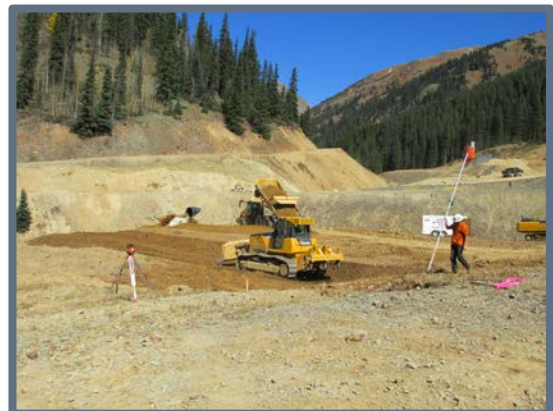
Grading and terracing of Geotube sedimentation area at Gladstone (10 October 2015).

- Began grading and terracing of the sedimentation Geotube pad at Gladstone.
- Continued monitoring of water quality at 6 locations twice daily. Associated metrics are summarized below.

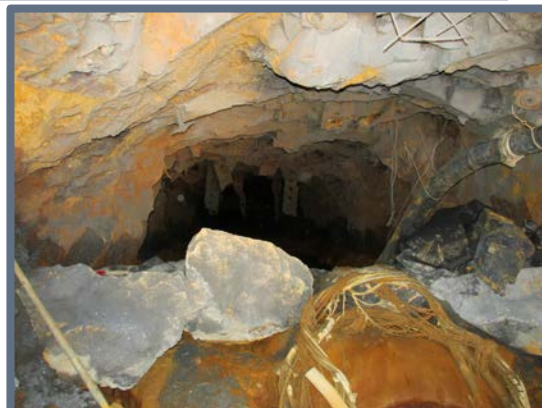
Cofferdam and dewatering pump inlet pipe inside GKM adit (10 October 2015).

- Starting 08 October 2015, water flowing from the GKM portal is being captured by a cofferdam inside the mine and mechanically pumped down from the mine site.
